Acoustic Imaging and Profiling: A New Tool for Underwater Inspection

Use of underwater acoustic imaging and profiling technology enabled the owner of the 50-year-old D'Arbonne Dam in north central Louisiana to pinpoint potential problems and make timely and cost-effective repairs.

By Zahir Bolourchi, Kenneth J. LaBry, Paul E. Booth, and Richard L. Glenn

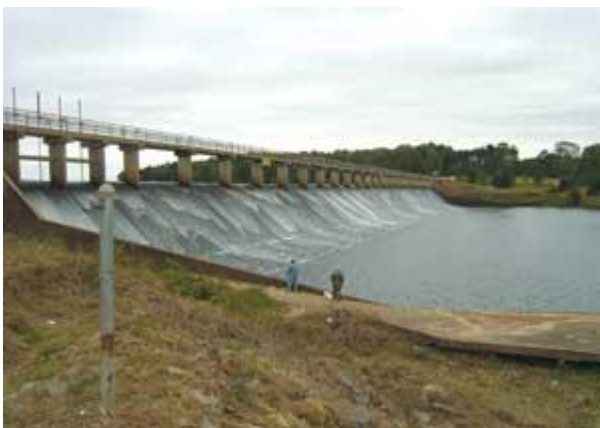
[Using underwater acoustic imaging and profiling at the 50-year-old D'Arbonne Dam in Louisiana, contractors generated a detailed model of sub-surface conditions. This model verified the presence of voids under the spillway apron; repair is nearing completion.](#)

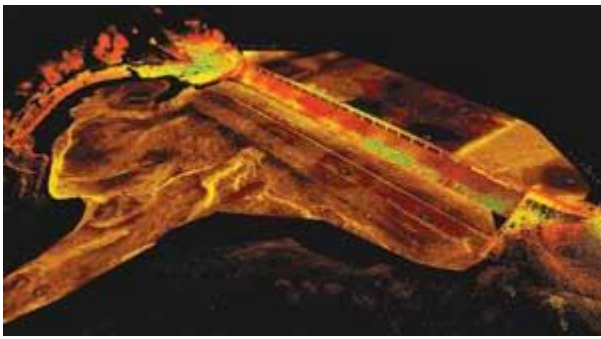
In reviewing the results from the inspections and the model, the features of immediate concern were two pairs of depression signatures (i.e., holes) in the sediment at the toe of the upstream side of the concrete dam structure. While relatively small in cross section, these signatures were of a similar nature to those that would signify the occurrence of piping in the sediment beneath the structure. Another potential explanation for these signatures was the transport of sediment through non-functioning water stops into the interior of the dam. A linear feature – observed with the underwater acoustic imaging technology – exiting near the floor blocks on the dam apron and projecting to the end of the apron supports this potential explanation. This feature was in alignment longitudinally along the dam with the northern pair of depression signatures, which were also the most prominent. The southern pair of depression signatures had no remarkable prominent correlation on the spillway side of the structure. However, they did correlate to a depressed area at the end of the spillway apron that was in alignment with the depression signatures on the spillway side of the structure.

Figure 1: Data collected from the high-definition laser scanning survey and from the underwater acoustic imaging and profiling were integrated to generate a comprehensive data set. The sonar imagery was then “draped” over the data to provide this visualization of the underwater features of D’Arbonne Dam.

Whatever the explanation for the cause, if these signatures did indicate piping, this could potentially result in abrupt dam system failure. Consequently, Fenstermaker recommended that the LA DOTD employ divers to conduct a visual underwater survey of the area in which these holes were observed acoustically. Fenstermaker also proposed that the divers be aided by an underwater acoustic imaging system in order to maximize efficiency, provide increased visualization in a low-visibility environment, and produce an objective, digital record of the divers’ investigations.

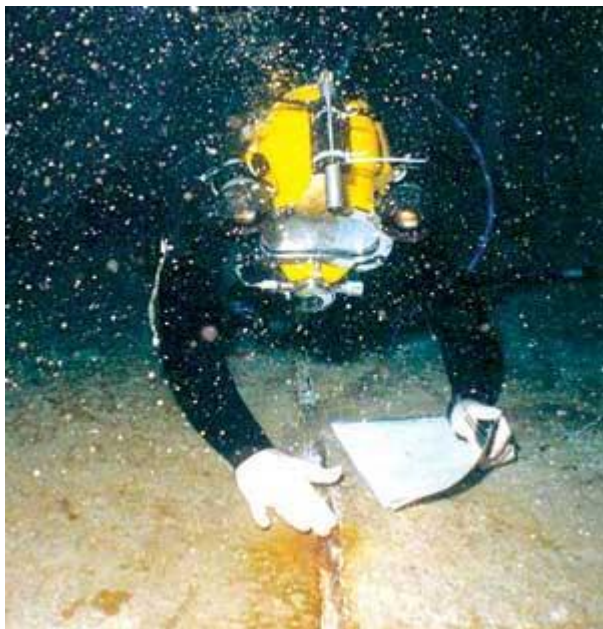
The divers from Glenn Underwater Services were mobilized to the D’Arbonne Dam on January 15, 2008. The divers utilized dye injection, directed by the acoustic imaging system, to first determine if significant flow existed at these holes. The dye did not pool on the lake side injection area, but was also not observed on the downstream side of the dam. This would indicate that significant flow did not exist at the holes. The divers subsequently investigated parallel areas inside the gallery, finding a compromised seal and water stop at a construction joint. This was allowing the intrusion of water and sediment into the gallery with the sediment slurry then, presumably, being carried through the gallery drains.

[At D'Arbonne Dam, divers used information gleaned from the use of acoustic imaging and profiling to pinpoint specifically where underwater repair work was needed.](#)

To reduce leakage, the divers temporarily repaired the joint until permanent re-sealing of the joint could be performed. They also noted debris at the toe of the upstream side of the dam structure in the area of the compromised joint. Debris in these areas can be a cause of turbulence, which, in turn, could cause joint erosion. Results and findings from the divers’ investigation indicated that piping was not occurring.
