Mini ROV plays major role

Technological advances have made ROVs even greater value in hydro power inspections. Caleb Adams and Richard L Glenn from Glenn Underwater Services highlight the advantage of deploying ROVS into situations deemed to be too dangerous for divers

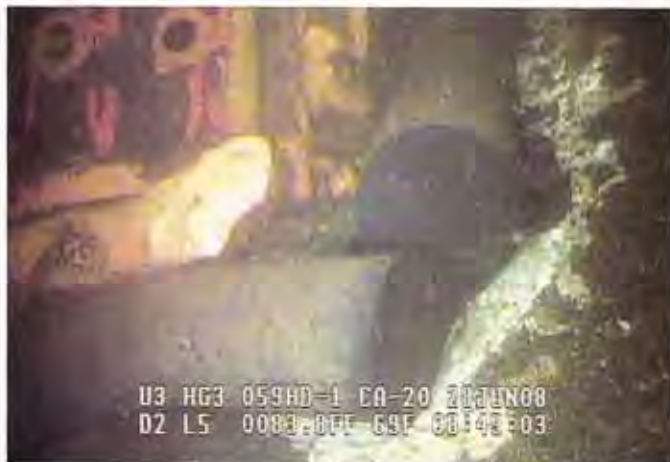
The gate did substantial damage to the concrete base of the scroll case

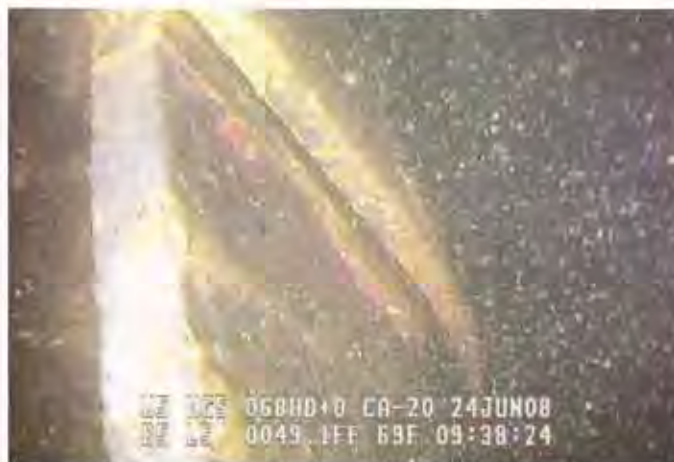
Poor visibility (as above) was overcome with the Tritech Micron Sonar

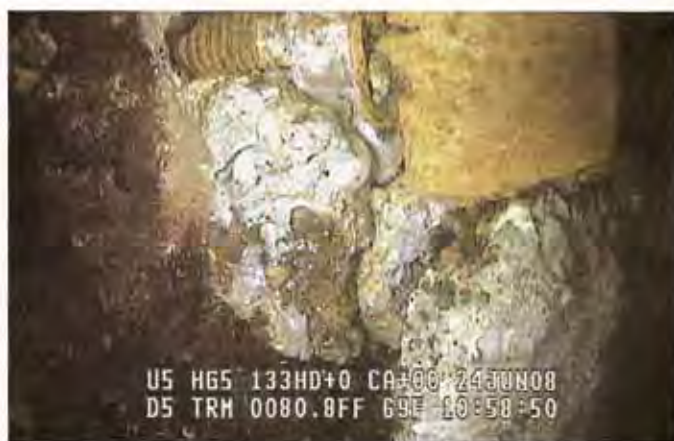
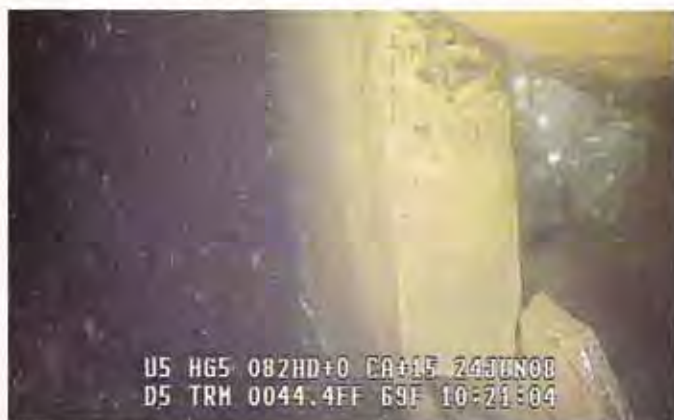
The particular environment that was discovered in the gate system was highly dangerous. Initial ROV dives discovered that the gate had sheared its downstream guides completely away due to failure of the concrete pier structure, and was precariously balanced against the remaining pier wall and scroll case downstream and off angle of its intended position.

Large masses of concrete that originally made up the guide pier were hanging in broken pieces from the mangled and twisted H-beam that served as the sealing surface of the guide.

Above and below: Images from the ROV show the substantial damage

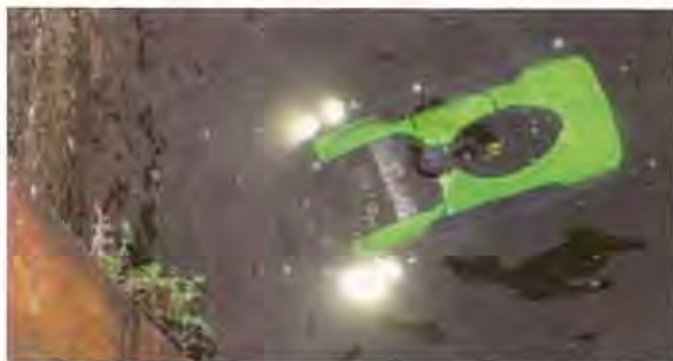
Below: Rov inspecting an intake guide
